CORNER RECORD

Agency Index 238 CR 37
Document Number CR 11200
County of CONTRA COSTA, California

Brief Legal Description MONUMENT LOCATED WITHIN LOMAS CANTADAS
REF APN: 265-100-006 150 LSM 21

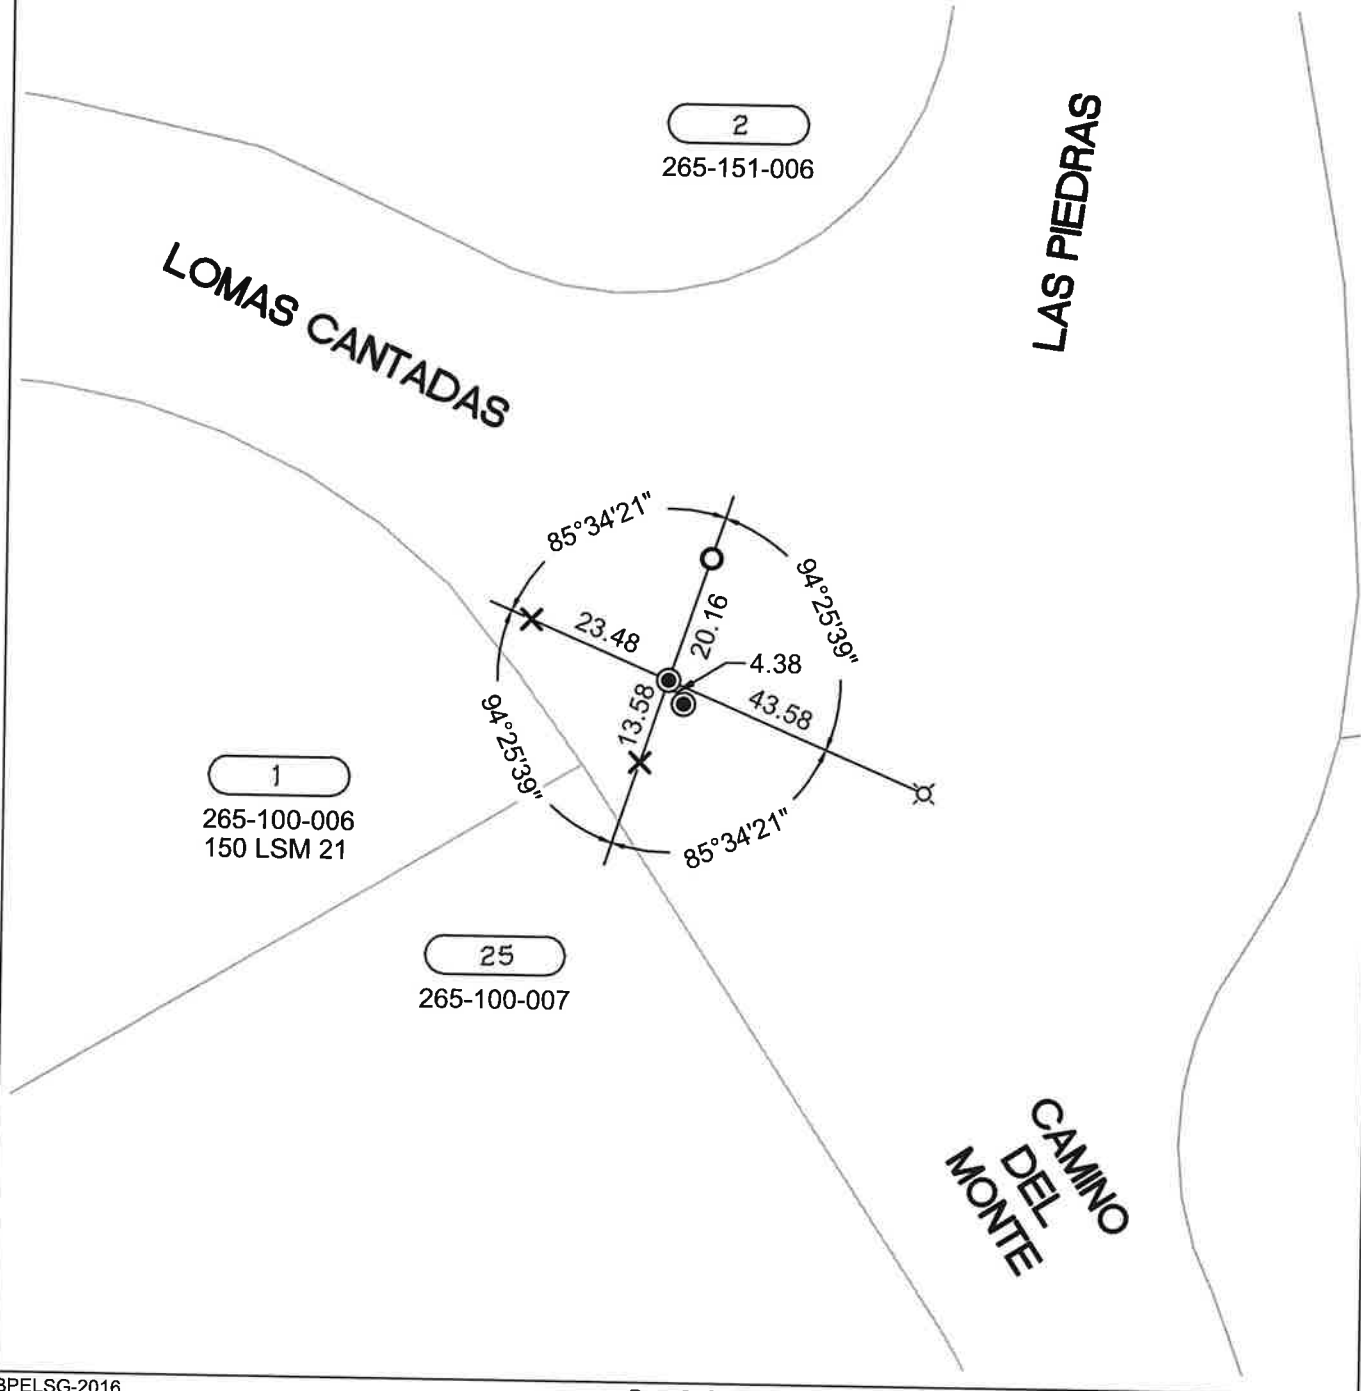
FOUND AND SET POINTS AS SHOWN ON PAGE 2.
THIS POINT WAS REFERENCED PRIOR TO A CONSTRUCTION PROJECT IN THE VICINITY.
THE TIES SHOWN HEREON ARE FOR THE PURPOSE OF PERPETUATING FOUND MONUMENTATION. NO CLAIM IS MADE AS TO THE RELATIONSHIP OF THE POINTS OR LINES SHOWN HEREON TO TRUE BOUNDARY LOCATION.
21051-Lomas Cantadas-CR-07

ALL MEASUREMENTS IN U.S. SURVEY FEET AND DECIMAL THEREOF
