CORNER RECORD

Agency Index 238 CR 39
Document Number CR 11202
County of CONTRA COSTA, California

City of ORINDA

Brief Legal Description MONUMENT LOCATED WITHIN LOMAS CANTADAS

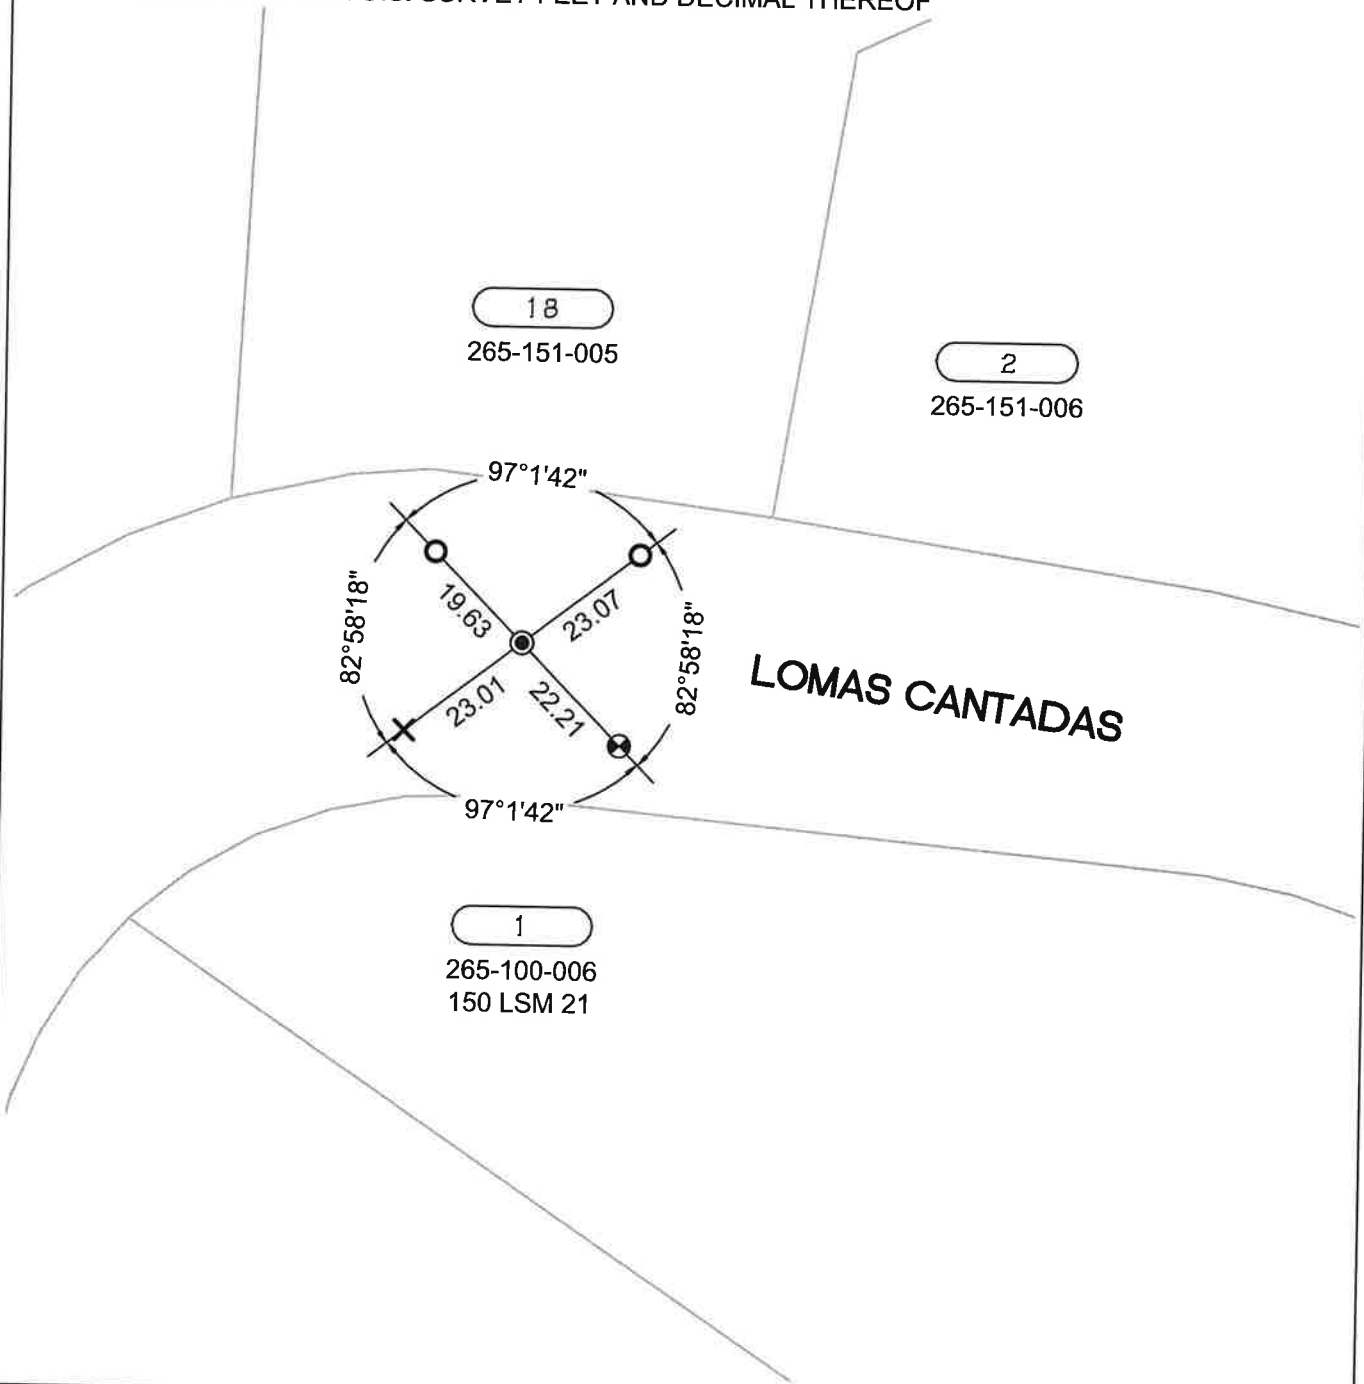
FOUND NAIL AND TAG LS 7136.

FOUND AND SET POINTS AS SHOWN ON PAGE 2.

THIS POINT WAS REFERENCED PRIOR TO A CONSTRUCTION PROJECT IN THE VICINITY.

THE TIES SHOWN HEREON ARE FOR THE PURPOSE OF PERPETUATING FOUND MONUMENTATION. NO CLAIM IS MADE AS TO THE RELATIONSHIP OF THE POINTS OR LINES SHOWN HEREON TO TRUE BOUNDARY LOCATION.
