CORNER RECORD

Agency Index 238 CR 46
Document Number 11209
County of CONTRA COSTA, California

Brief Legal Description SURFACE MONUMENT LOCATED WITHIN LAS PIEDRAS
REFERENCE APN: 265-153-013, LAKE ORINDA HIGHLANDS UNIT No. 1 (20 M 528)

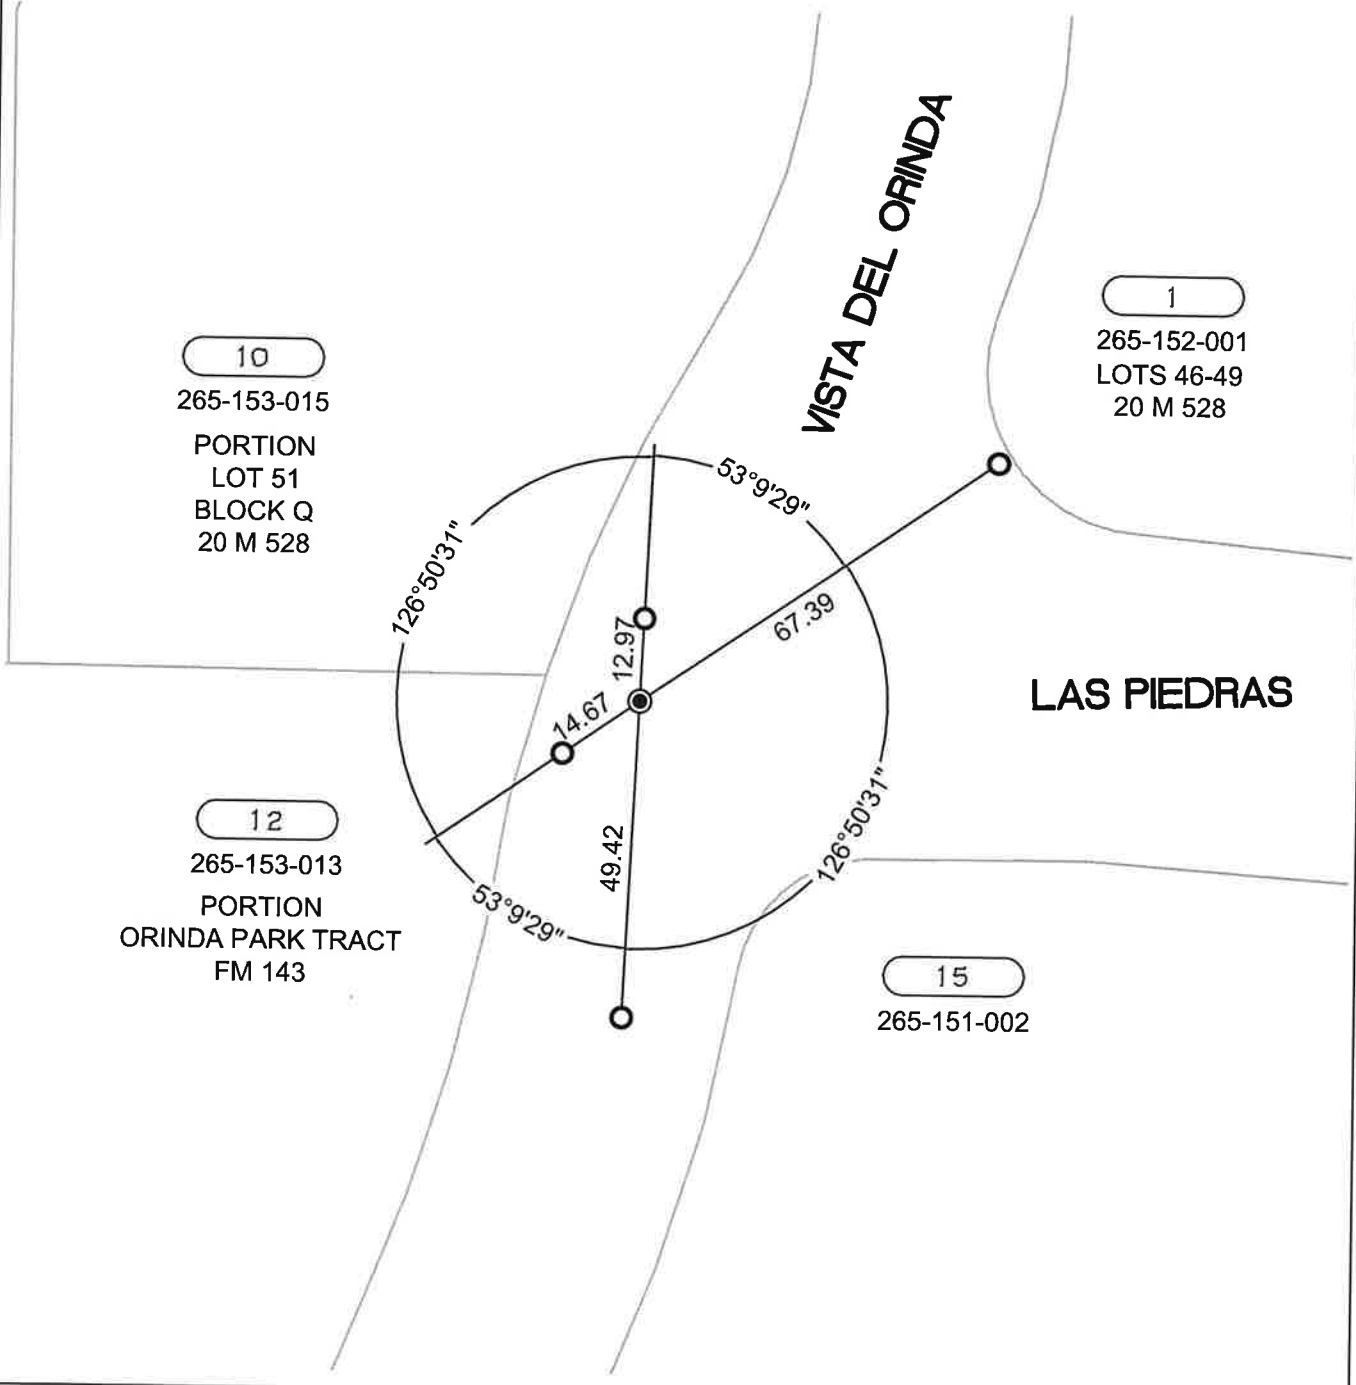
FOUND REBAR & CAP "LS 3272" AT EDGE OF PAVEMENT.

FOUND AND SET POINTS AS SHOWN ON PAGE 2.

THIS POINT WAS REFERENCED PRIOR TO A CONSTRUCTION PROJECT IN THE VICINITY.

THE TIES SHOWN HEREON ARE FOR THE PURPOSE OF PERPETUATING FOUND MONUMENTATION. NO CLAIM IS MADE AS TO THE RELATIONSHIP OF THE POINTS OR LINES SHOWN HEREON TO TRUE BOUNDARY LOCATION.
