238 CR 50 Agency Index CORNER RECORD **Document Number** CONTRA COSTA , California County of City of ORINDA MONUMENT LOCATED WITHIN CAMINO SOBRANTE **Brief Legal Description** REFERENCE APN: 262-021-003, MAP HACIENDAS DEL ORINDA UNIT No. 1 (18 M 440) COORDINATES (Optional) **CORNER TYPE** Government Corner Elevation

21051-Camino Sobrante-CR-19

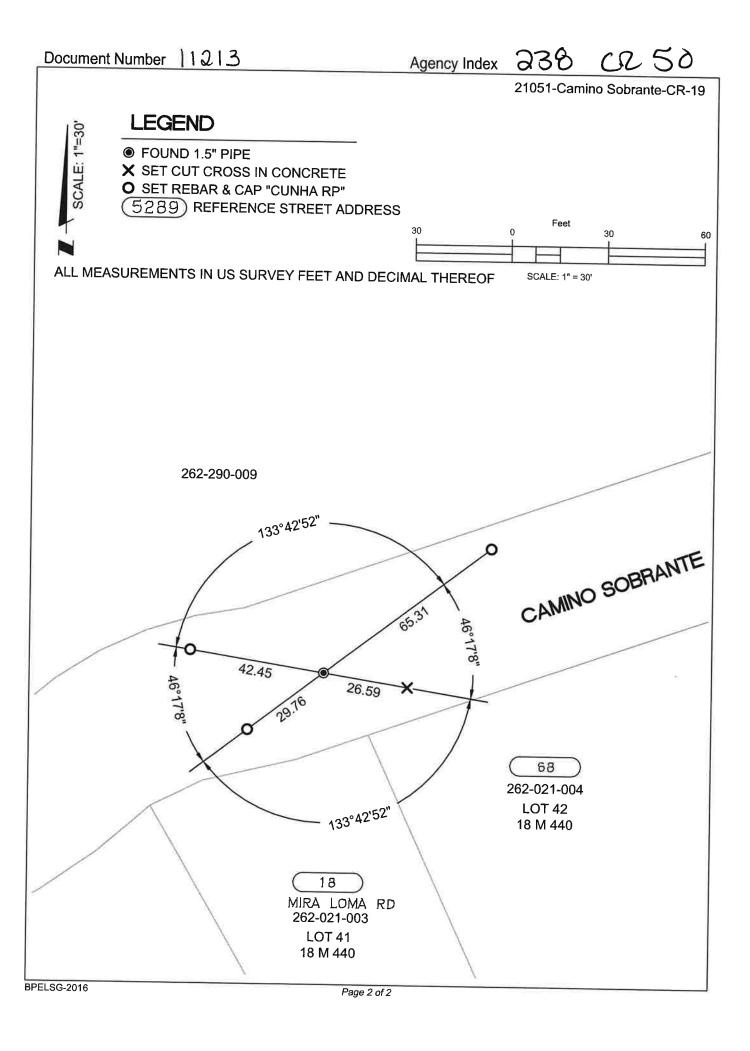
See sheet #2 for description (s):

FOUND AND SET POINTS AS SHOWN ON PAGE 2.

FOUND 1.5" PIPE, BENT & DAMAGED. REFERENCED POINT AT WHICH PIPE GOES VERTICAL...

MONUMENT BURIED 0.9' BELOW GRADE. EXCAVATED PRIOR TO REFERENCING.
